Repairing Foam Cored Albacore Cockpit Interiors

By Barney Harris

HAPCO Marine

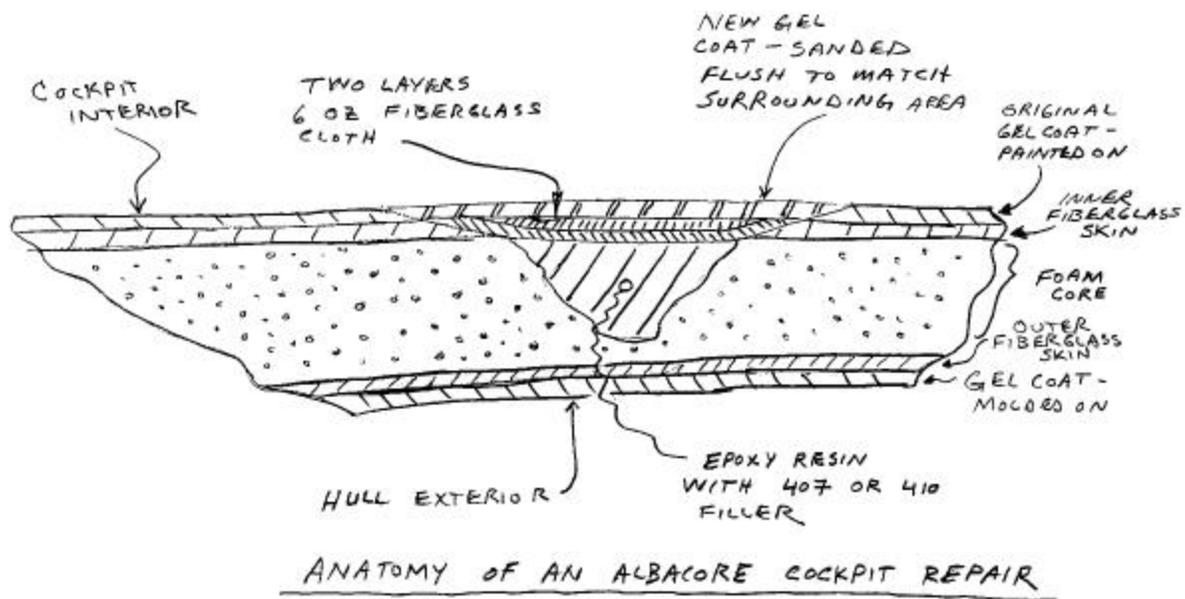
Cored hull Albacores are somewhat susceptible to damage to the floor of their cockpits. This damage can take the form of an indentation from a concentrated point load from stepping on a small hard object such as a pebble or tool. This will poke through the inner fiberglass skin and into the foam core. Another common form of damage occurs when the hull has a point load applied outside the hull - as from improperly positioned trailer bunks or setting the hull on the ground with an uneven surface.. This will create a crack or series of cracks on the hull's interior, usually aligned fore and aft. Fortunately repairing this sort of damage is straightforward. I have done these repairs to several boats including my own, and have developed the following process.

Next, fill the dent with epoxy filler such as west 105 resin and 205 or 206 hardener with a lightweight filler such as the West 407 or 410. Apply a thin coat of pure resin to the area being filled to ensure a good bond. Then mix the filler into the remaining resin until you reach a mayonnaise or peanut butter consistency. Apply the filler with a putty knife and fair it into the surrounding area as well as you can. Allow this to cure overnight.

Now, prepare for a fiberglass patch by sanding the cured filler area flush with the surrounding area and wiping it down with acetone and a clean paper towel. Carefully mask off the area to be coated so that inadvertent spills do not mess up the boat interior. Cut two pieces of 6 ounce fiberglass cloth to the exact shape of the area being repaired.

Now, mix a small batch of West epoxy resin and paint the damage area with a thin coat. Apply one piece of fiberglass cloth and wet out with resin completely by dabbing with a small brush. Try to use a little resin as possible. Apply the second piece of fiberglass cloth and wet it out with resin. The cure can be speeded by gentle heating with a 75 watt light bulb if desired. Watch for drips - clean them up before they harden
